**EMERGENCY SPILLWAY PERFORMANCE,
UPPER RED ROCK CREEK WATERSHED,
OKLAHOMA**

ARS-S-108

May 1976

By W. O. Ree¹

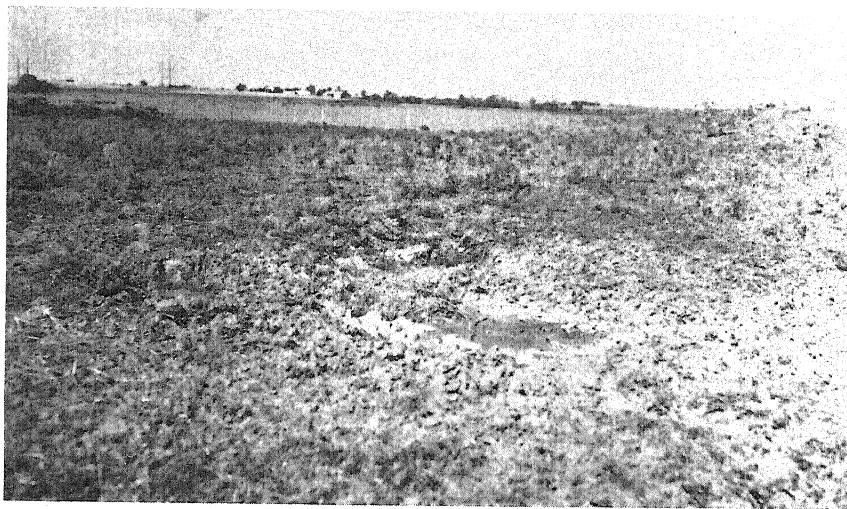
Figure 5 is a closeup view of the head of one of the deeper rills. The scour here is about 2 feet deep and extends to the shale bedrock. This part of the spillway was subjected to the 6.7 feet per second flow velocity. Immediately downstream of the spillway crest is a small area scoured to a depth of 5 inches (fig. 6).

FIGURE 6.—Scoured area in site 24 spillway just downstream from spillway crest. The cover on the adjoining area is thin, poor, and short.

The site 24 spillway started to erode during a flow event which had a peak mean velocity of 6.7 feet per second. The spillway appeared to have been heavily grazed, and this may have been responsible for its condition. Cattle trails and “stomp” areas were present in the spillway at the time of inspection. Therefore, it is reasonable to assume that the eroded areas also had suffered from similar cattle activity.
